SECOND FIVE-YEAR REVIEW REPORT BEULAH LANDFILL SUPERFUND SITE PENSACOLA, ESCAMBIA COUNTY, FLORIDA EPA ID: FLD980494660

September 24, 2003

SECOND FIVE-YEAR REVIEW REPORT FOR BEULAH LANDFILL FORMER SUPERFUND SITE PENSACOLA, ESCAMBIA COUNTY, FLORIDA EPA ID: FLD980494660

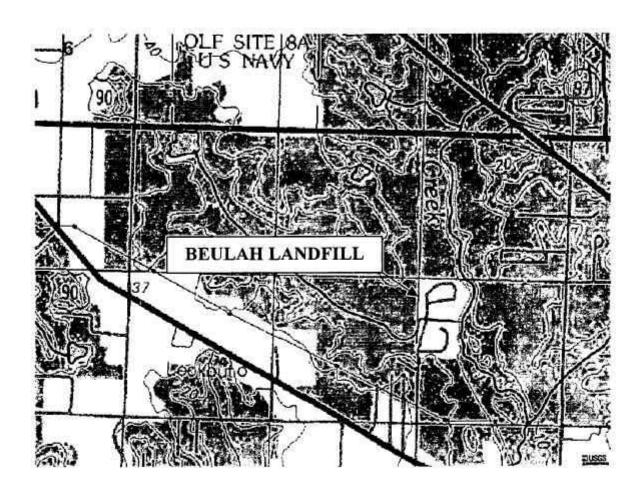
FIGURE 3

BEULAH LANDFILL TOPOGRAPHIC MAP

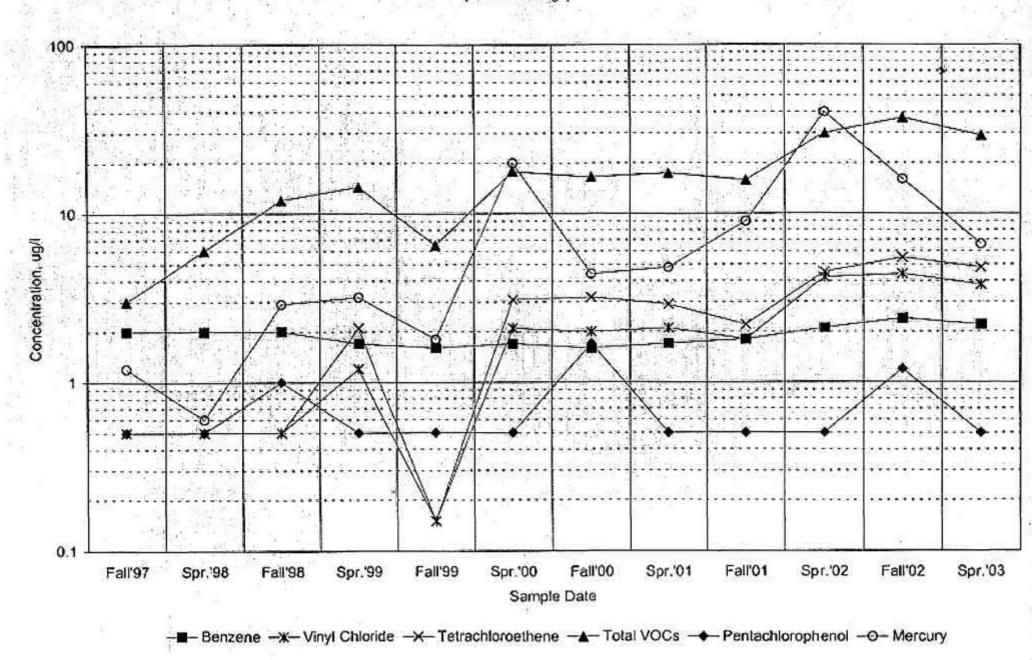
ANALYTICAL HISTORY; BMW-1/1R BEULAH LANDFILL, ESCAMBIA CO., FLORIDA (all values in ug/l)

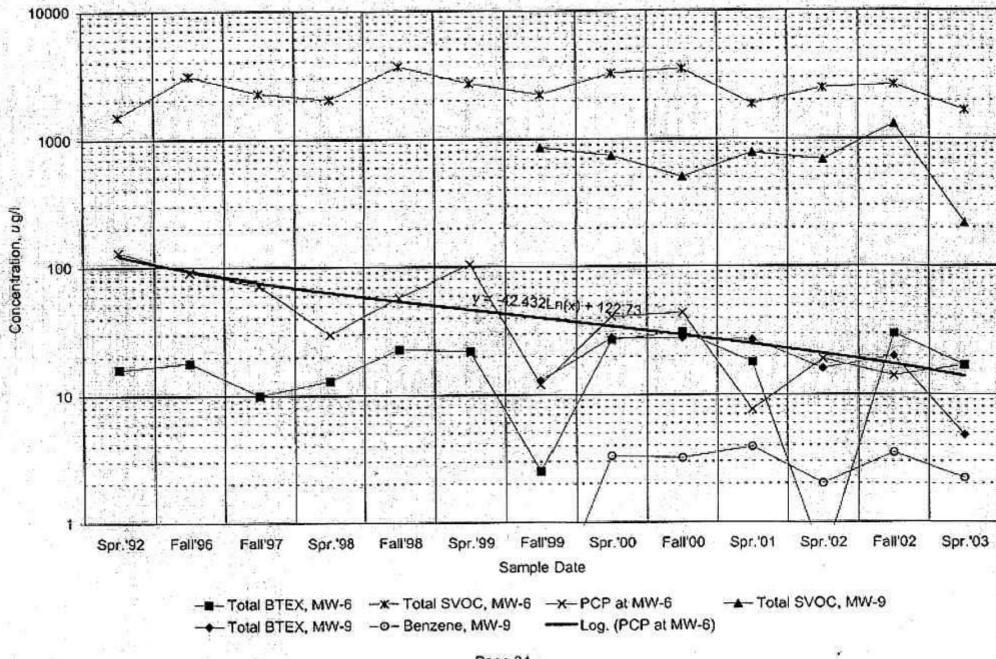
ANALYTICAL HISTORY; MW-6 & MW-9' BEULAH LANDFILL, ESCAMBIA CO., FLORIDA

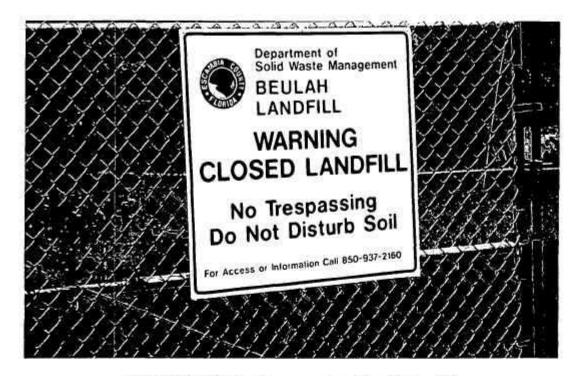
PHOTOGRAPH 1. Entrance gate to Beulah Landfill

The main entrance into Beulah Landfill was locked and provided with the appropriate signage marked with "no trespassing" and" do not disturb soil". This in the only entrance provided for vehicular traffic and the road was noted to be in good condition. This road continues around the perimeter of the northern half and southern half of the landfill and provides access to the monitor wells and surface water sampling locations.

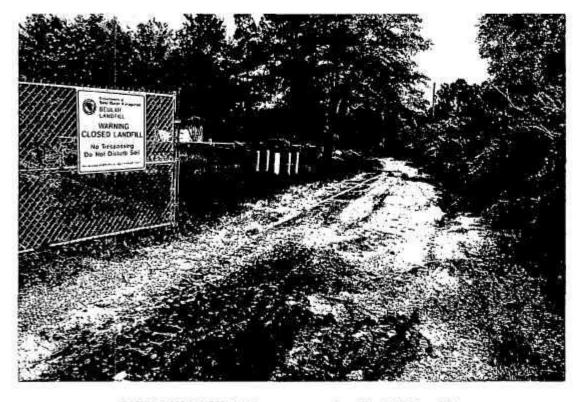
PHOTOGRAPH 2. Entrance road to Beulah Landfill.

The major issue noted during the inspection is the incomplete fencing of the site. As mentioned previously, ESDSW is in negotiations with International Paper Company to acquire property along the southern portion of the landfill. At this time, this area- of the property remains unfenced and susceptible to trespassing. It is recommended that the fencing in this area be completed as soon as possible. Elevenmile Creek provides a natural boundary on the east side of the landfill however access is still possible during periods of low rainfall.

MW-10 shown in center with perimeter fencing and adjacent residences shown on left.

- Incomplete Perimeter Fencing The perimeter fencing should be completed to protect the cap from damage. The trespasser scenario performed during the risk assessment indicated that there was not an unacceptable risk. The risk assessment was conducted before the cap was installed over the landfill, which further reduced the risk from direct exposure. Although the lack of complete perimeter fencing does not represent a threat to human health of the environment, it is recommended that the perimeter fence be completed to protect the cap from damage by trespassers.

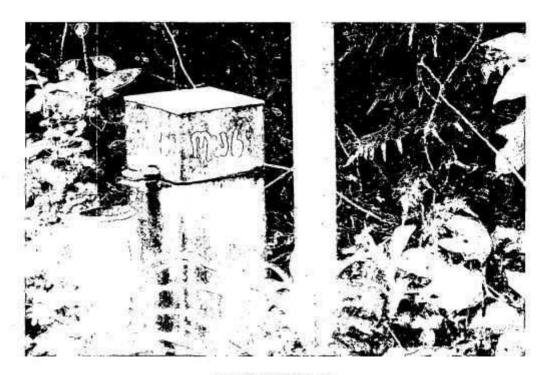
PHOTOGRAPH 9. View of MW-6 without lock.

Each of the eleven monitor wells at the site was located at the time of the inspection and noted for condition. Monitor wells at the site were all provided with protective steel surface casings, and most with protective steel posts. Each monitor well was provided with a lock with the exception of MW-6 (Photograph 9).

1. Monitoring Wells (natural attenuation remedy) ☐ Functioning ☐ Routinely sampled ☐ Properly secured/locked ☐ Good condition ☐ All required wells located ☐ Needs O&M ☐ N/A					
Remarks MW-6 is in need of a new padlock.

- The PRP should complete the perimeter fencing and place appropriate signage as soon as possible.
- The PRP should perform an inventory of the existing monitor wells and replace any locks where necessary.
- The PRP should submit a plan to FDEP providing the proposed remedial actions to address the contamination indicated in the southern portion of the landfill.

Issue	Recommendations/Follow-up Actions	Party Responsible	Oversight Agency	Milestone
Access Control	Complete perimeter fencing	PRPs	EPA	3/30/04
Monitor well is not secured	Conduct a complete inventory of the existing wells and provide locks where necessary	PRPs	EPA	11/30/03
Groundwater contamination is in excess of standards	Comply with FDEP Closure Permit Requirements	PRPs	EPA	11/30/03
